Site Description

Six Mile Park

Recent Measurements at Port Lavaca Six Mile Park

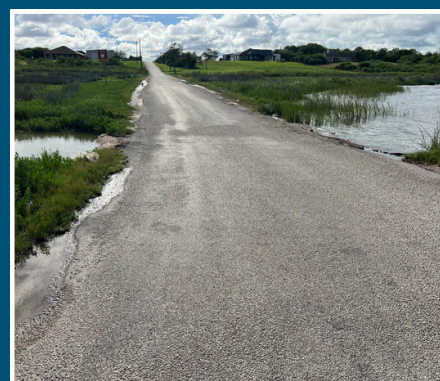
Figure 1. Graphs water levels measured in feet at the Six Mile Park from March 26th to March 30th 2025. This graph shows a sharp spike in the water levels due to heavy rain storm. This event caused heavy flooding that lead to a road at 6 Mile Park becoming submerged Please note the exact water level is not accurate due to not having the exact height of the sensor at this time

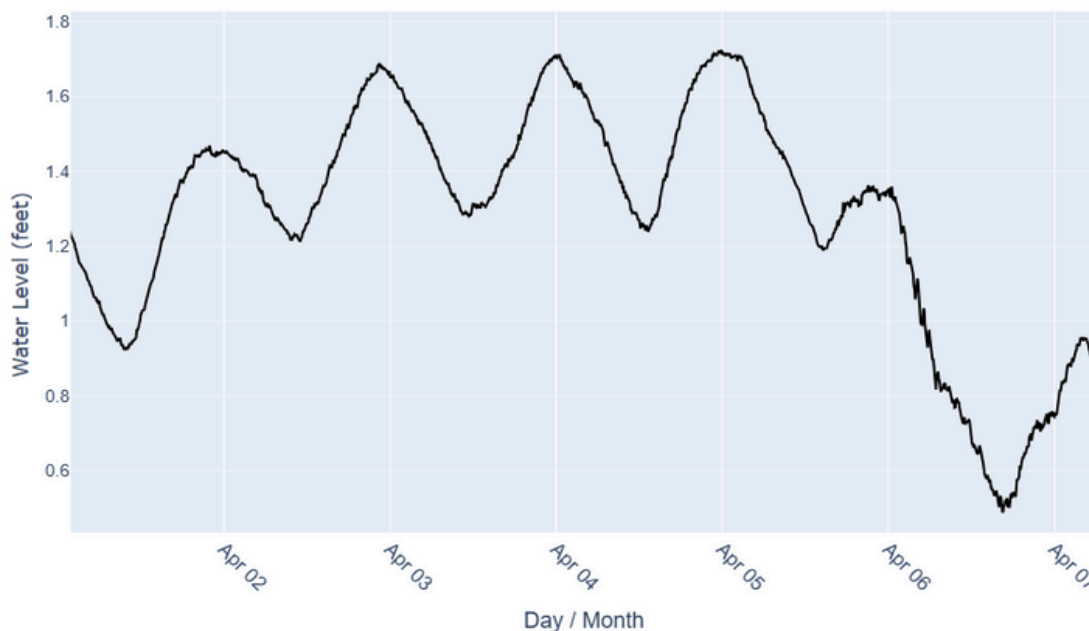
Figure 2. Graphs water levels measured in feet at Six Mile Park from April 1st to April 7th. This graph shows 3 spikes in water levels at Six Mile Park due to unusually high winds These wind events caused the road at Six Mile Park to flood over at three different times over the course of the week. Please note the exact water level is not accurate due to not having the exact height of the sensor at this time.
